**Office of the New York State Attorney General Letitia James**

**Office of Special Investigation**

# Report on the Investigation into the Death of Wesley Soper

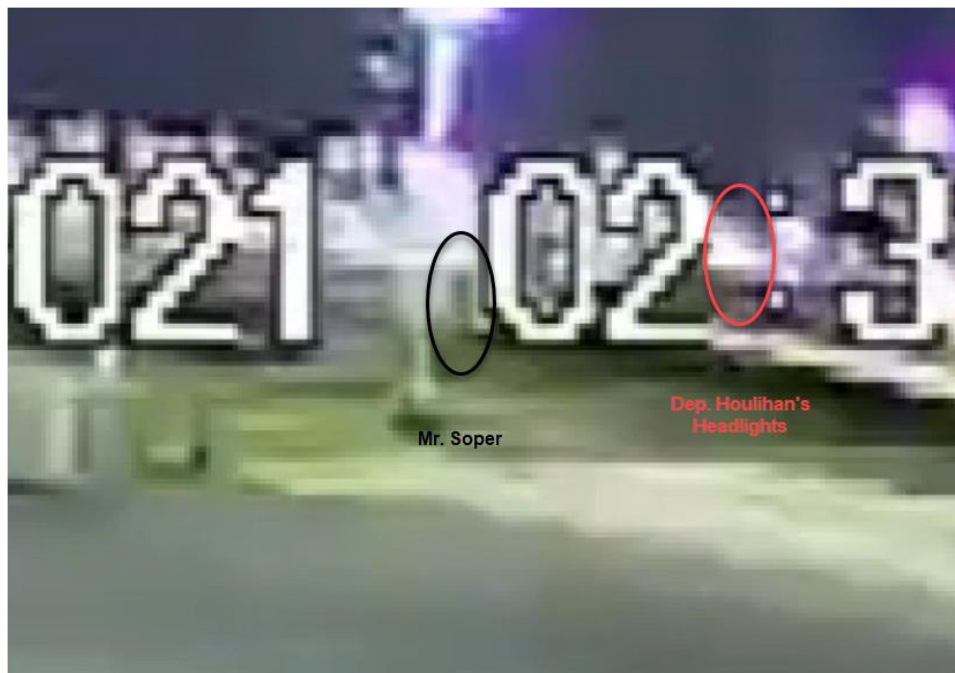
*Image taken from close-up of surveillance footage captured from the north wall of Walgreens showing Mr. Soper and the headlights from Dep. Houlihan's patrol car.*

Although there is no overhead surveillance video at the intersection, a camera mounted on the northern wall of a Walgreens store captured Dep. Houlihan's car approaching the intersection and Mr. Soper (faintly and from a distance) walking, without stopping or pausing, into the road. That footage, made for and kept by Walgreens, contained irremovable date and time stamps that obscured the collision. Close-up still photos taken from that video, are below.

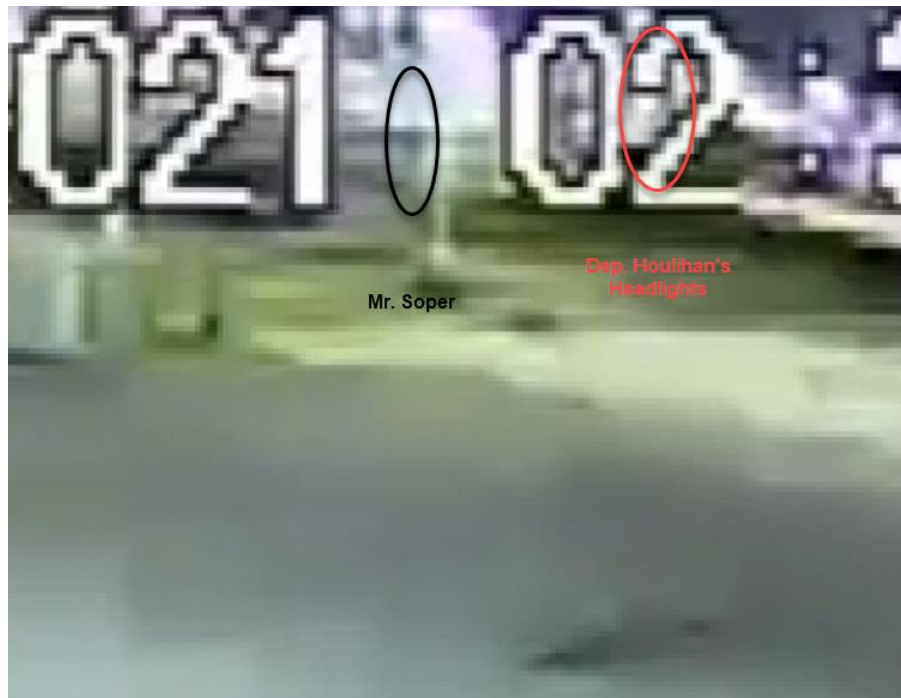
*Image taken from close-up of surveillance footage captured from the north wall of Walgreens showing Mr. Soper and the headlights from Dep. Houlihan's patrol car captured less than one second after the preceding image.*

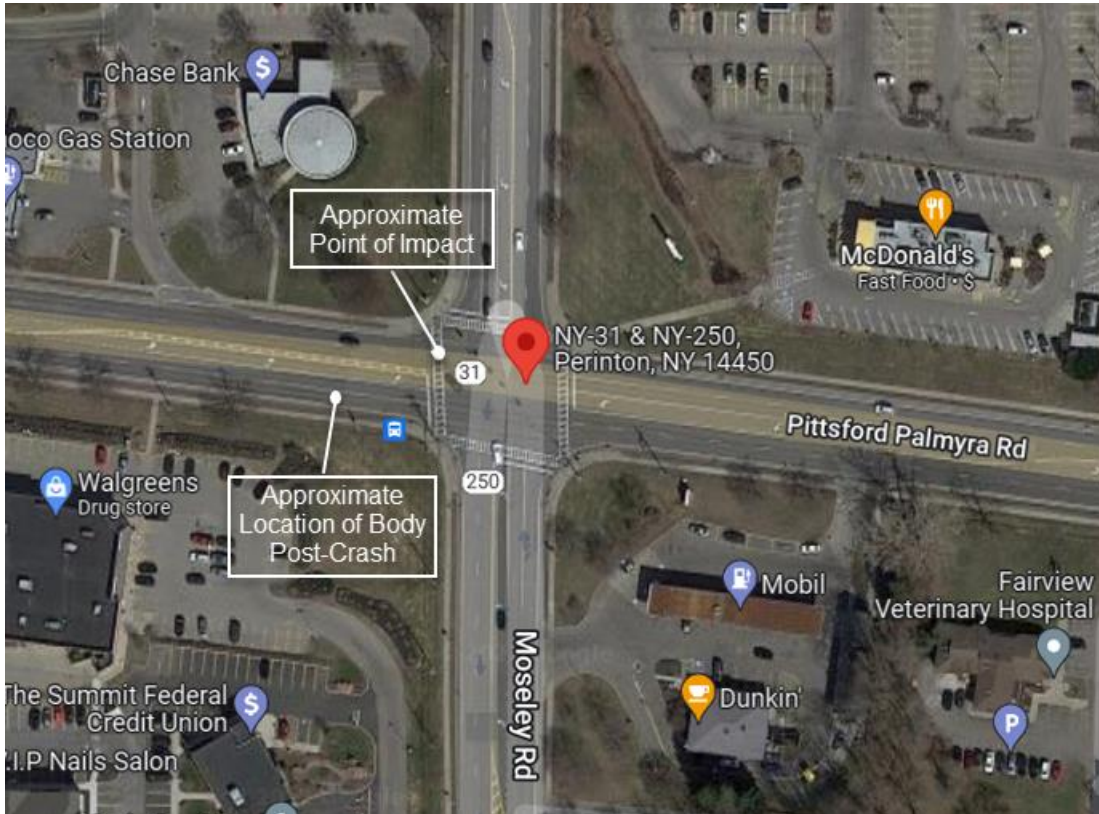
*The intersection of Pittsford-Palmyra Rd. and Moseley Rd. showing the approximate point of impact and the place where Mr. Soper's body came to rest.*

body then made continuous contact with the patrol car, causing Mr. Soper's upper torso to slap onto the hood of the car and causing his head to strike the windshield. Mr. Soper's body then travelled in a southwest direction for approximately 88 feet before coming to rest in the eastbound lane of Pittsford-Palmyra Rd.
